Checklist for Stormwater Report

TABLE 1: ORIGINAL, EXISTING & PROPOSED CONDITIONS - PEAK RUNOFF RATES & TOTAL RUNOFF VOLUMES
1089 Millbury Street - Worcester, Massachusetts

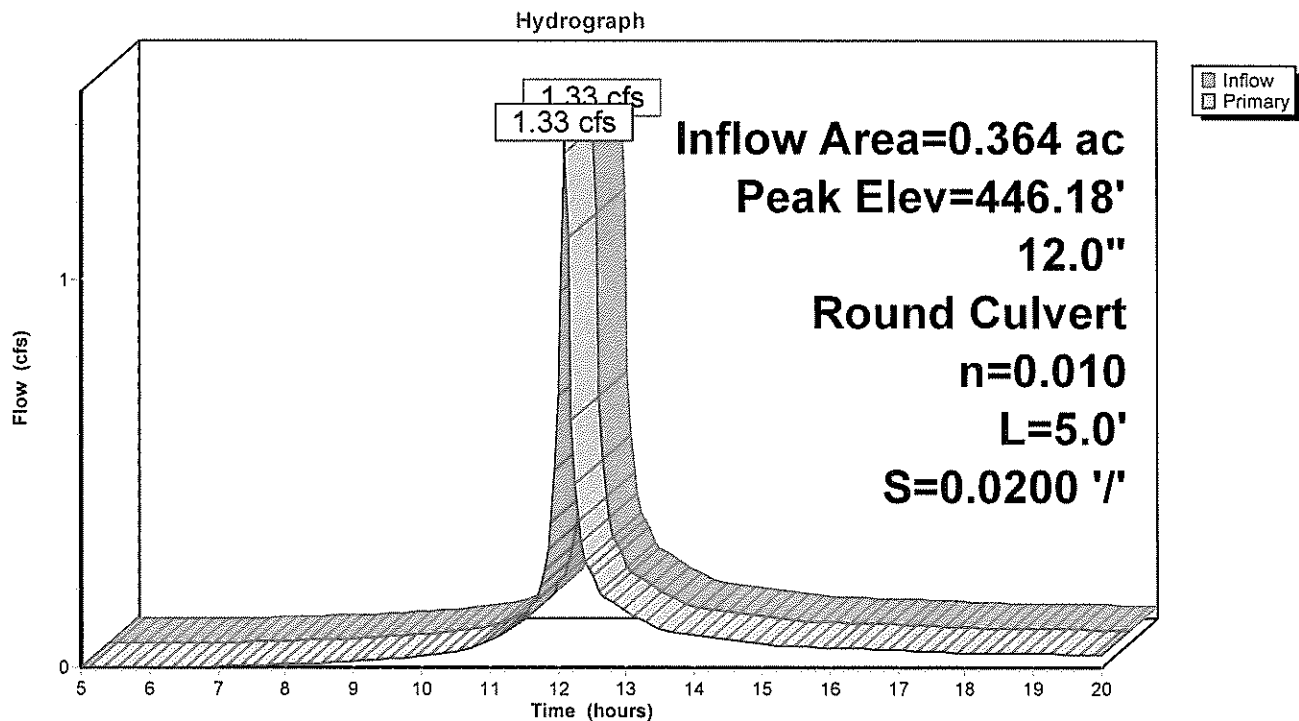
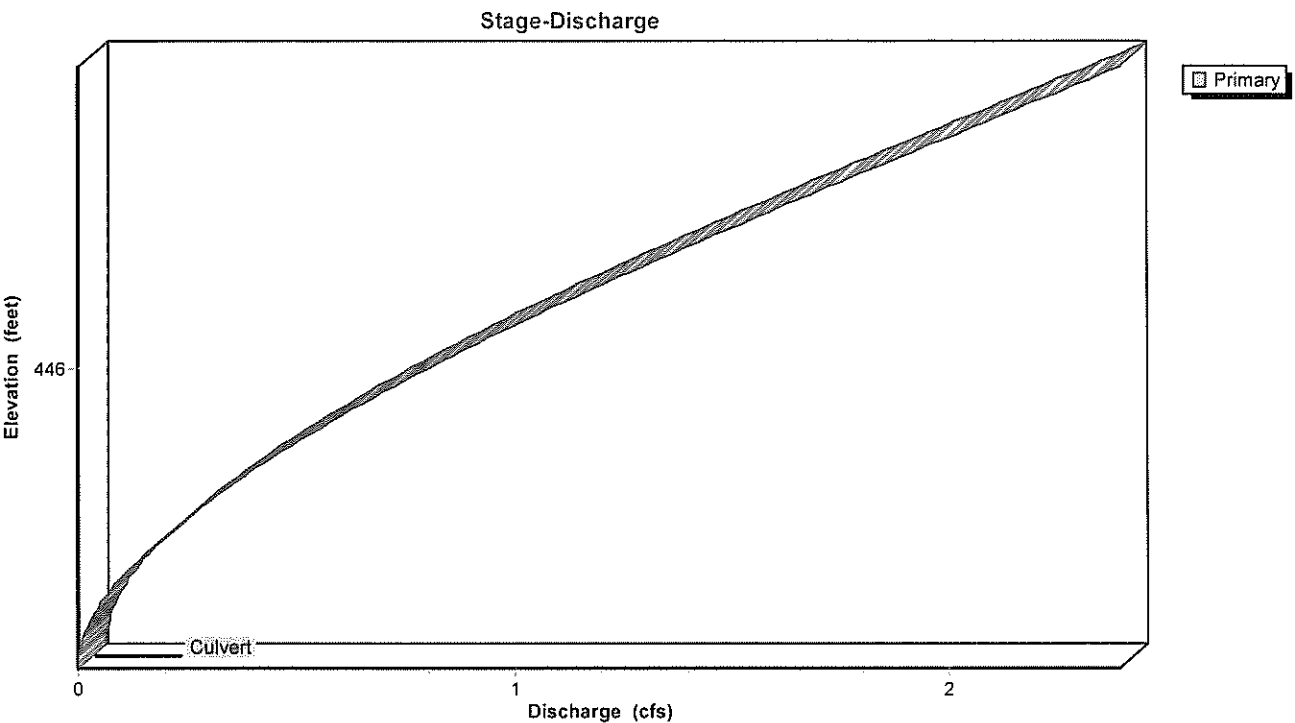
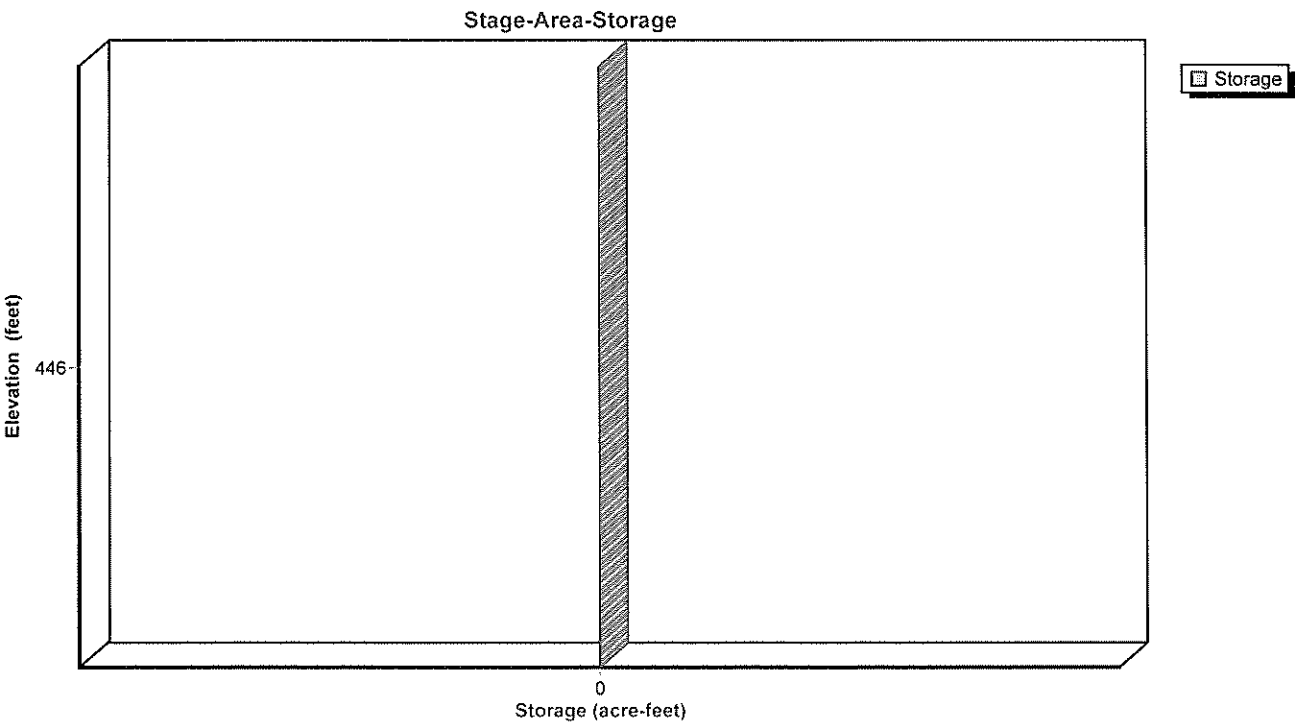
Summary for Pond CB1: Catch Basin 1

Inflow Area = 0.364 ac, 0.00% Impervious, Inflow Depth > 2.86" for 25-Year event
 Inflow = 1.33 cfs @ 12.11 hrs, Volume= 0.087 af
 Outflow = 1.33 cfs @ 12.11 hrs, Volume= 0.087 af, Atten= 0%, Lag= 0.0 min
 Primary = 1.33 cfs @ 12.11 hrs, Volume= 0.087 af
 Routed to Pond IT : Interceptor?Recharge Trench

Primary OutFlow Max=1.29 cfs @ 12.11 hrs HW=446.17' (Free Discharge)
 1=Culvert (Barrel Controls 1.29 cfs @ 3.29 fps)

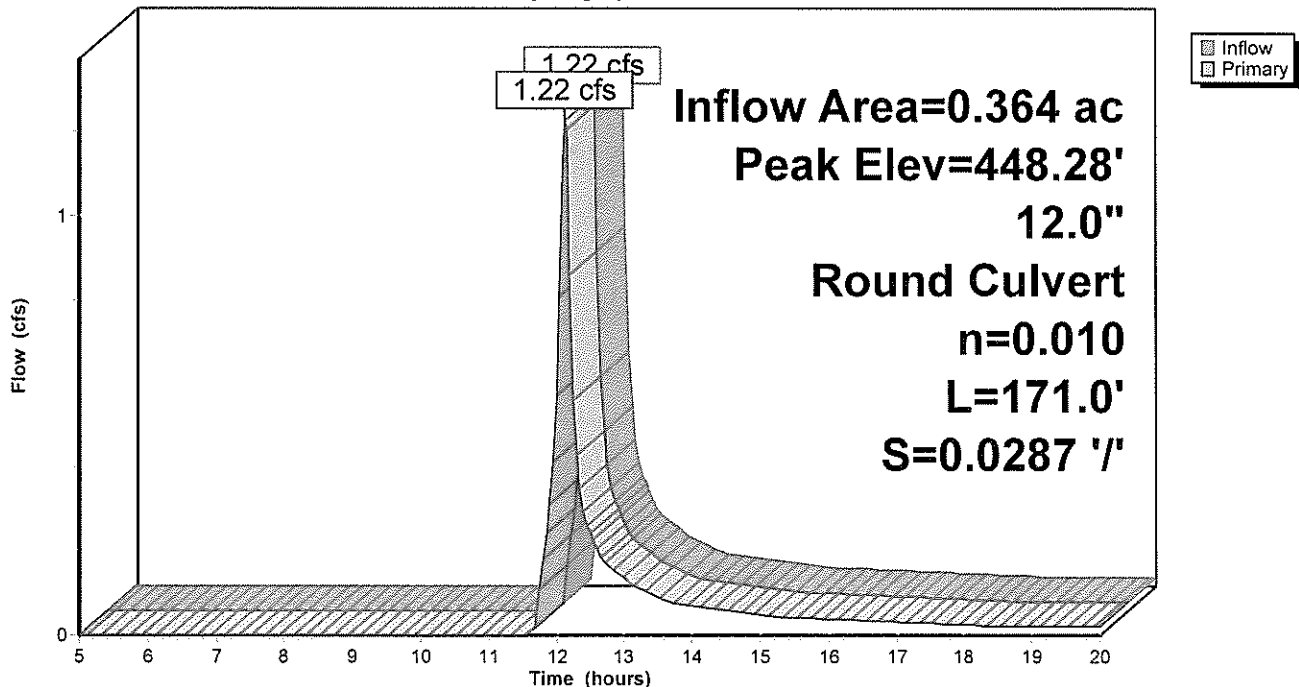
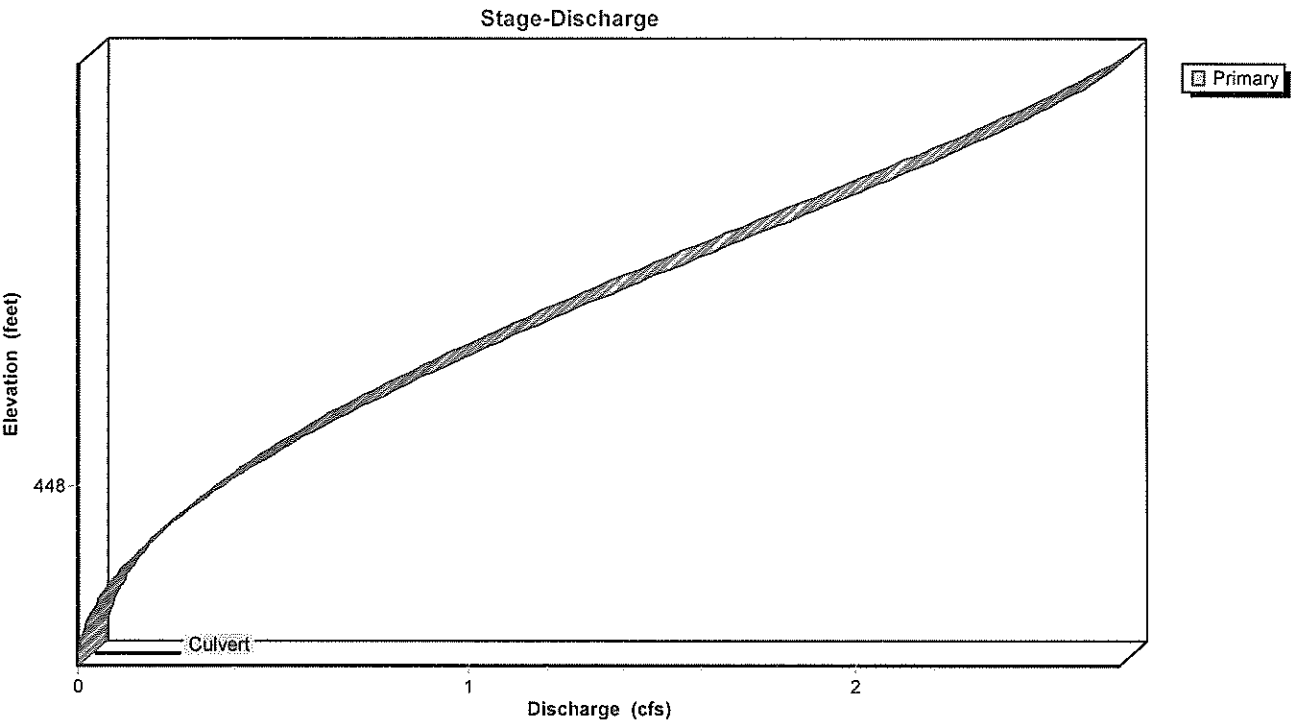
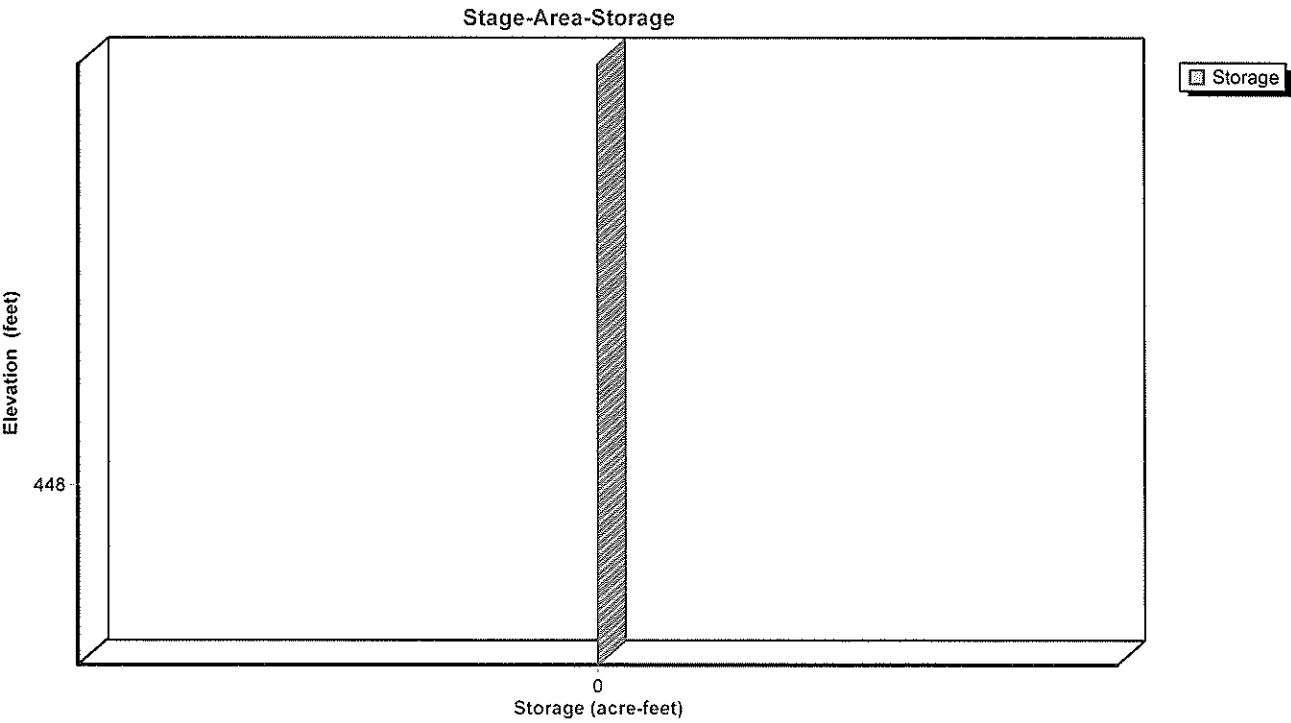
Summary for Pond CB2: Catch Basin

Inflow Area = 0.364 ac, 0.00% Impervious, Inflow Depth > 2.13" for 25-Year event
 Inflow = 1.22 cfs @ 12.13 hrs, Volume= 0.065 af
 Outflow = 1.22 cfs @ 12.13 hrs, Volume= 0.065 af, Atten= 0%, Lag= 0.0 min
 Primary = 1.22 cfs @ 12.13 hrs, Volume= 0.065 af
 Routed to Reach DL : 12" D PVC Drail Line to CB2 in Millbury Street & Municipal Sewer

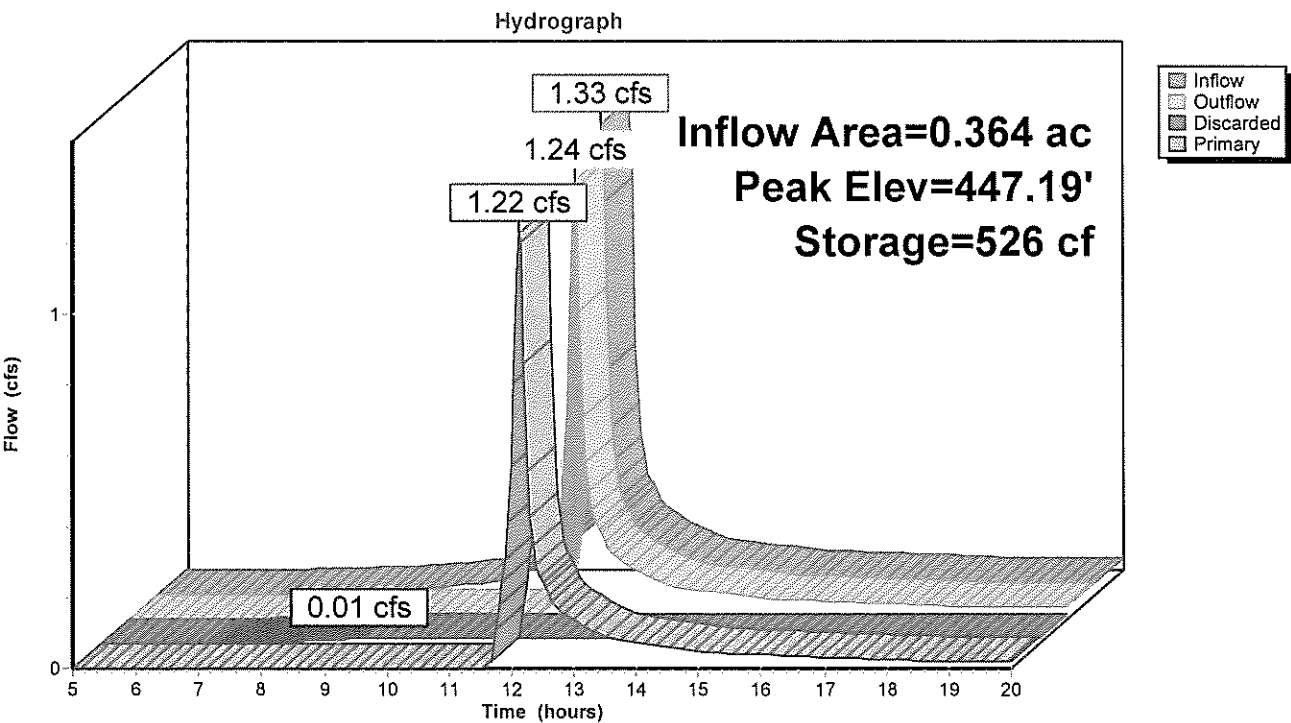
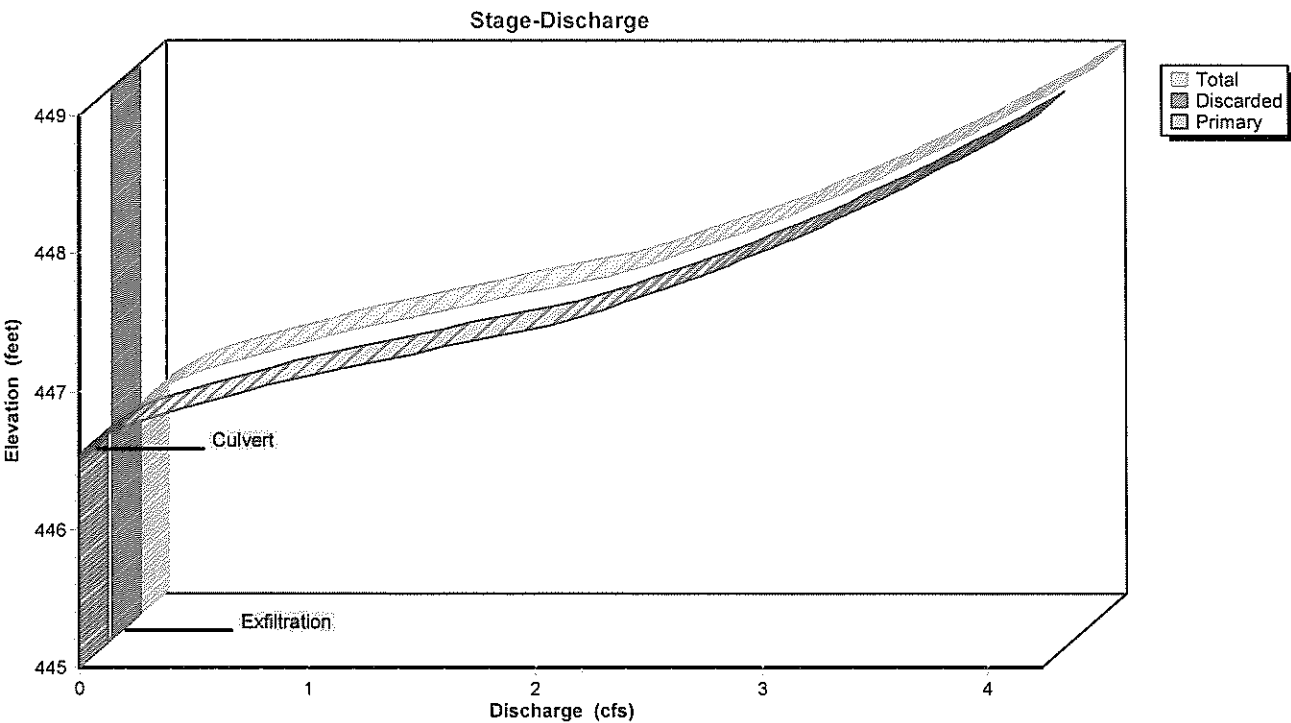
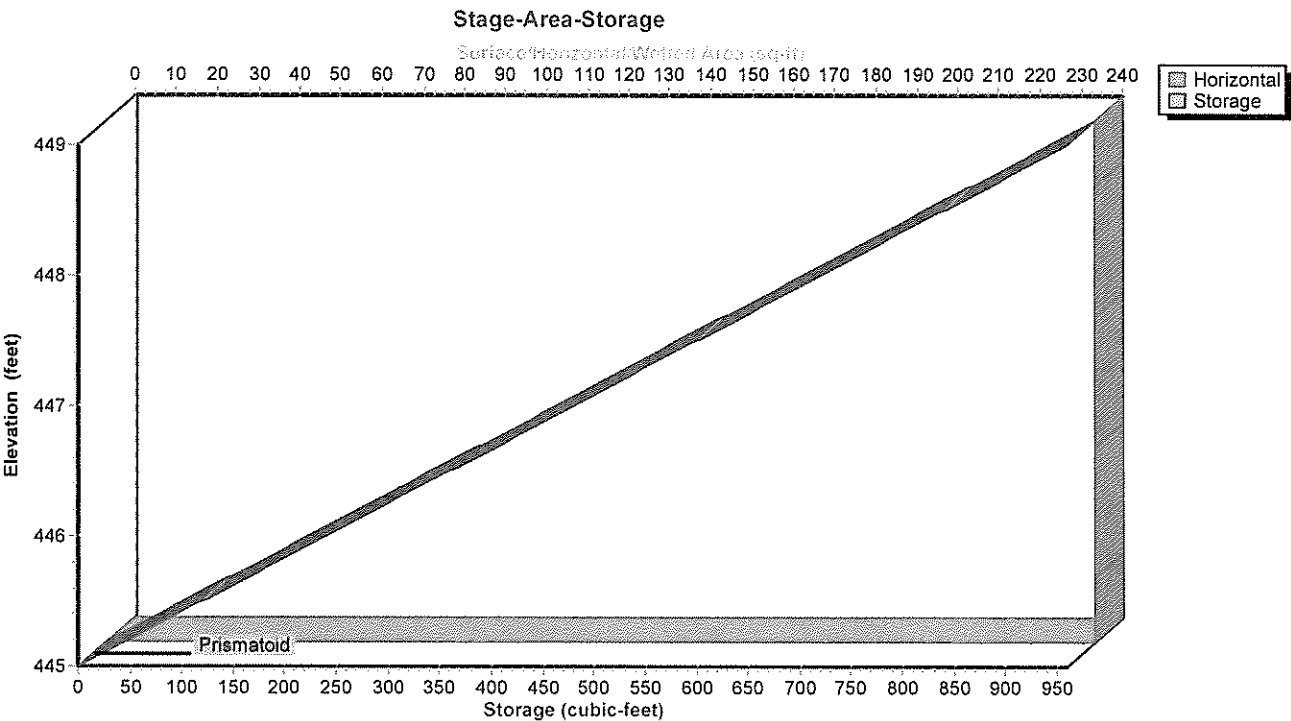
Summary for Pond IT: Interceptor?Recharge Trench

Inflow Area = 0.364 ac, 0.00% Impervious, Inflow Depth > 2.86" for 25-Year event
 Inflow = 1.33 cfs @ 12.11 hrs, Volume= 0.087 af
 Outflow = 1.24 cfs @ 12.13 hrs, Volume= 0.078 af, Atten= 7%, Lag= 1.7 min
 Discarded = 0.01 cfs @ 9.10 hrs, Volume= 0.013 af
 Primary = 1.22 cfs @ 12.13 hrs, Volume= 0.065 af
 Routed to Pond CB2 : Catch Basin

Primary OutFlow Max=1.18 cfs @ 12.13 hrs HW=447.18' (Free Discharge)
 ↑2=Culvert (Barrel Controls 1.18 cfs @ 2.95 fps)

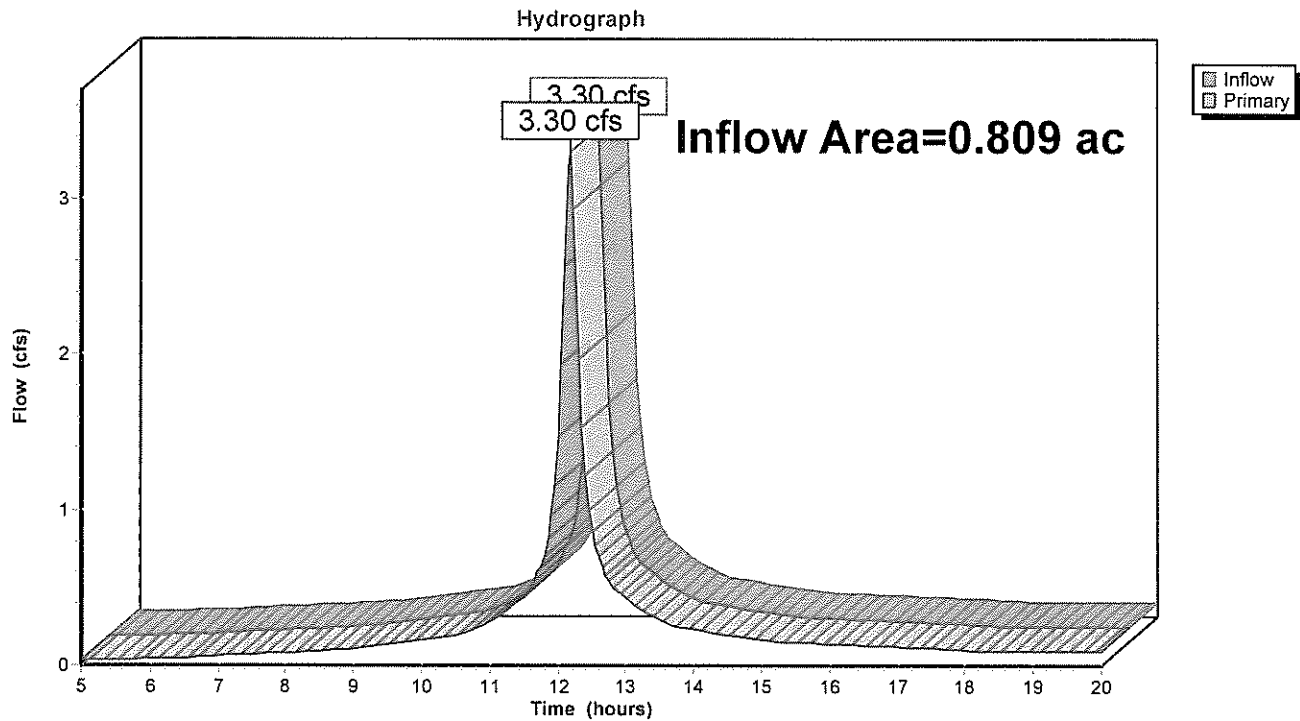
Summary for Link C-M.S.: Design Point - Current Conditions - Millbury Street

Inflow Area = 0.809 ac, 11.27% Impervious, Inflow Depth > 4.30" for 25-Year event
Inflow = 3.30 cfs @ 12.18 hrs, Volume= 0.290 af
Primary = 3.30 cfs @ 12.18 hrs, Volume= 0.290 af, Atten= 0%, Lag= 0.0 min

Primary outflow = Inflow, Time Span= 5.00-20.00 hrs, dt= 0.05 hrs

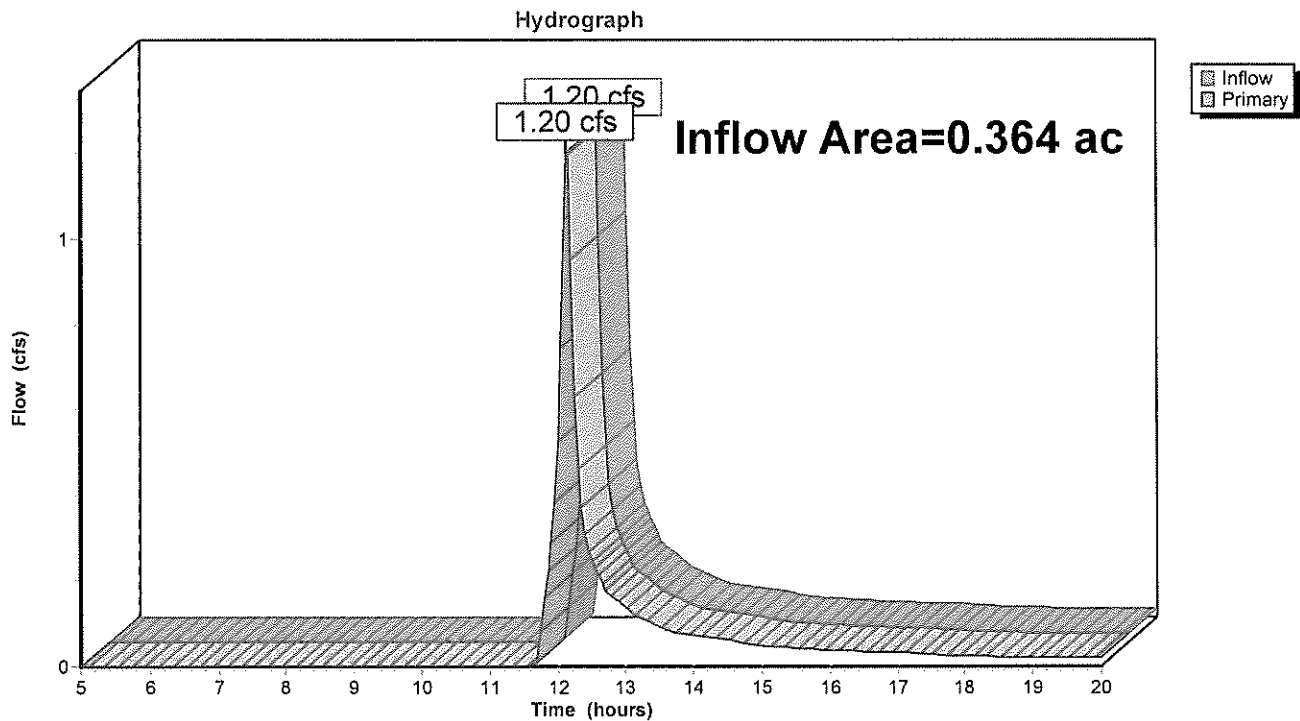
Summary for Link CB3: Design Point - Municipal Catch Basin in Millbury Street

Inflow Area = 0.364 ac, 0.00% Impervious, Inflow Depth > 2.13" for 25-Year event
 Inflow = 1.20 cfs @ 12.14 hrs, Volume= 0.065 af
 Primary = 1.20 cfs @ 12.14 hrs, Volume= 0.065 af, Atten= 0%, Lag= 0.0 min

Primary outflow = Inflow, Time Span= 5.00-20.00 hrs, dt= 0.05 hrs

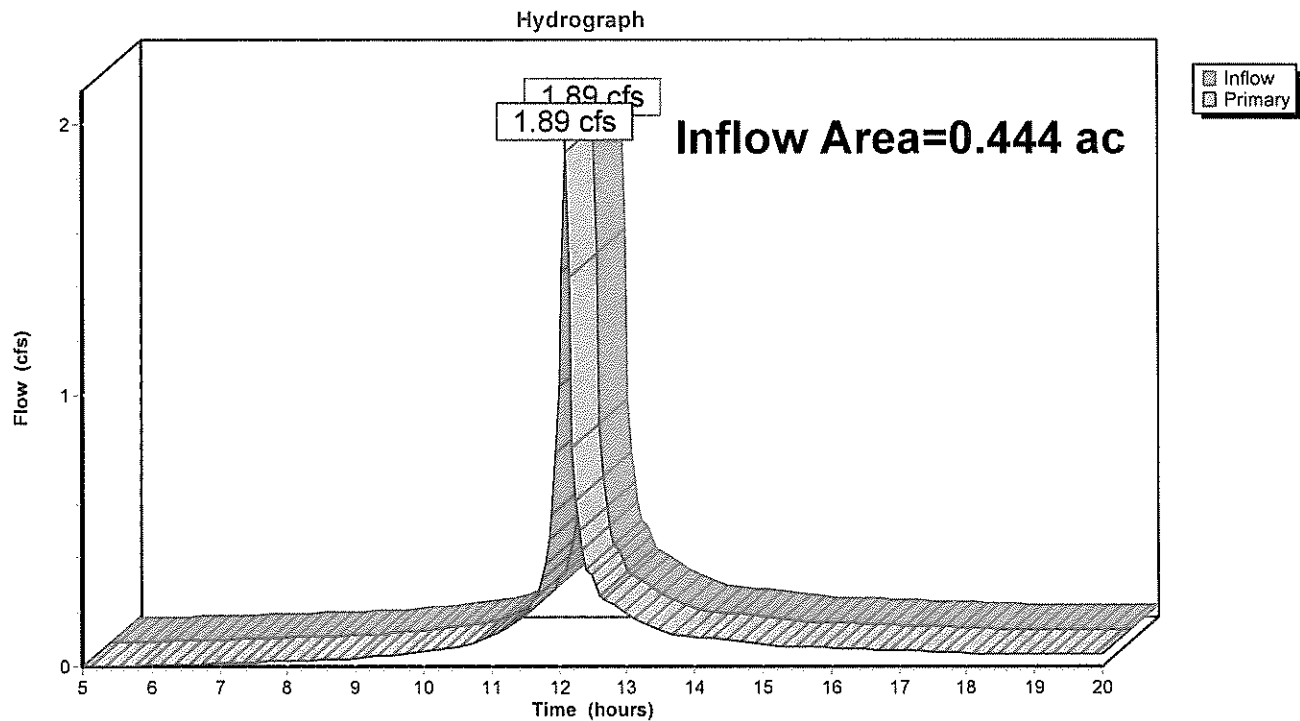
Summary for Link MS: Design Point - Millbury Street

Inflow Area = 0.444 ac, 20.50% Impervious, Inflow Depth > 3.33" for 25-Year event
 Inflow = 1.89 cfs @ 12.10 hrs, Volume= 0.123 af
 Primary = 1.89 cfs @ 12.10 hrs, Volume= 0.123 af, Atten= 0%, Lag= 0.0 min

Primary outflow = Inflow, Time Span= 5.00-20.00 hrs, dt= 0.05 hrs

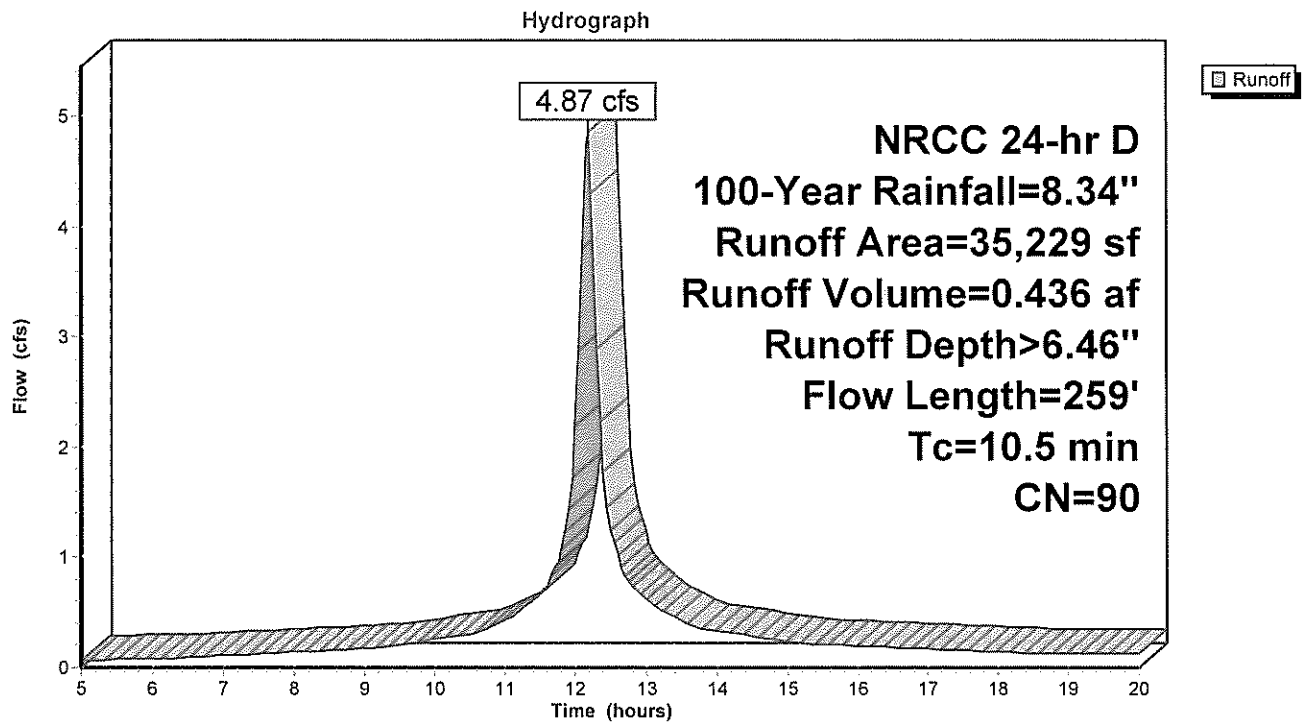
Summary for Subcatchment 1089: Current 2020 Conditions 1087-1089 Millbury St.TOTAL LOT

Runoff = 4.87 cfs @ 12.18 hrs, Volume= 0.436 af, Depth> 6.46"
 Routed to Link C-M.S. : Design Point - Current Conditions - Millbury Street

Tc (min)	Length (feet)	Slope (ft/ft)	Velocity (ft/sec)	Capacity (cfs)	Description
9.8	32	0.0600	0.05		Sheet Flow, Sheet Flow
					Woods: Dense underbrush n= 0.800 P2= 3.13"
0.1	73	0.4500	10.80		Shallow Concentrated Flow, Shallow Concentrated
					Unpaved Kv= 16.1 fps
0.6	154	0.0840	4.67		Shallow Concentrated Flow, Shallo Concentrated
					Unpaved Kv= 16.1 fps
10.5	259	Total

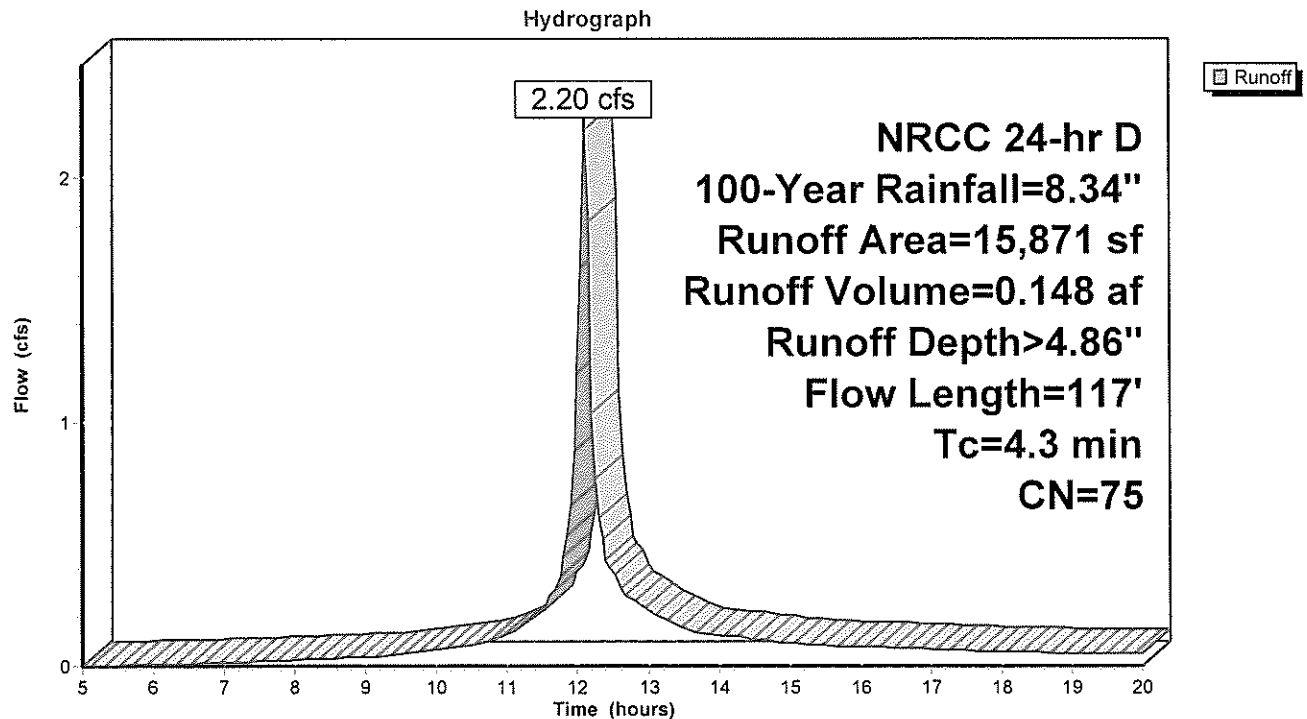
Subcatchment P-A: Poposed 2021 Conditions 1087-1089 Millbury St. Upper Section to Drain Syst

ary for Subcatchment P-A: Poposed 2021 Conditions 1087-1089 Millbury St. Upper Section to Dra

Runoff = 2.20 cfs @ 12.10 hrs, Volume= 0.148 af, Depth> 4.86"
 Routed to Pond CB1 : Catch Basin 1

Tc (min)	Length (feet)	Slope (ft/ft)	Velocity (ft/sec)	Capacity (cfs)	Description
2.4	10	0.2000	0.07		Sheet Flow, Sheet Flow-1 Trees Woods: Dense underbrush n= 0.800 P2= 3.13"
1.6	40	0.3000	0.41		Sheet Flow, Sheet Flow 2 - Grass Grass: Short n= 0.150 P2= 3.13"
0.3	67	0.3000	3.83		Shallow Concentrated Flow, Shallow Concentrated Short Grass Pasture Kv= 7.0 fps
4.3	117	Total

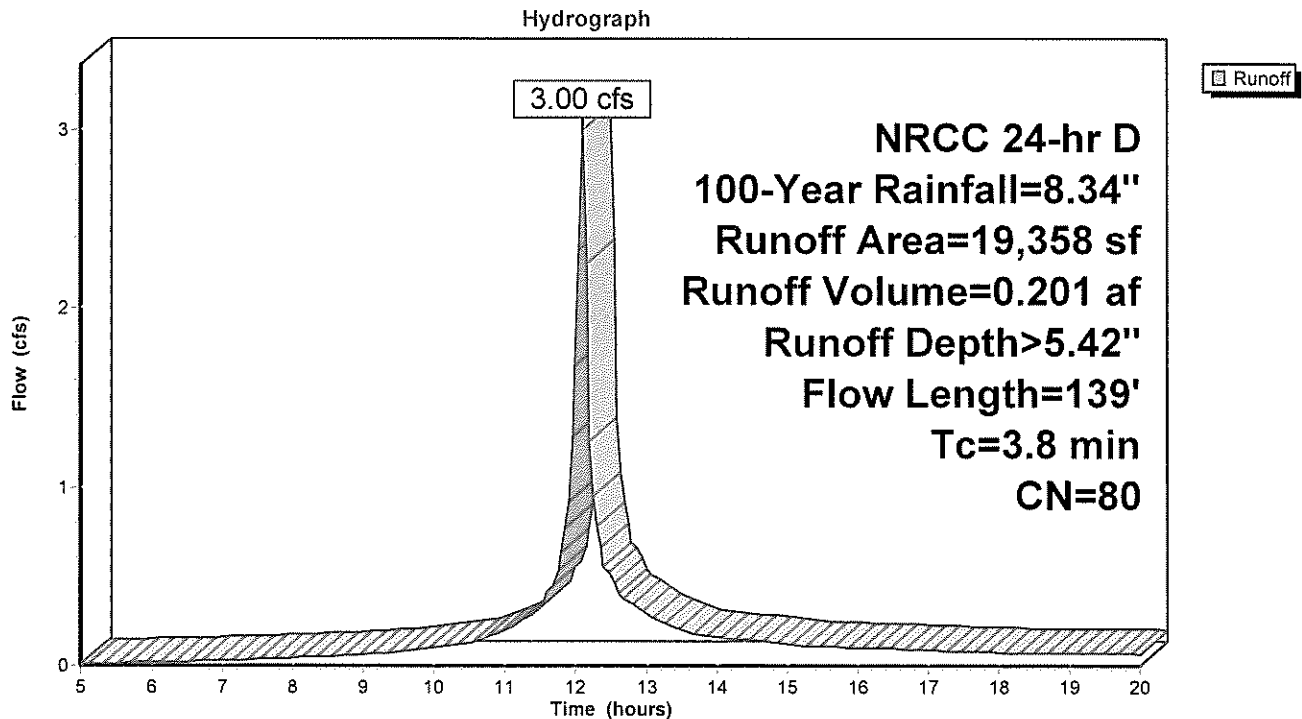
Hydrograph for Subcatchment P-B: Poposed 2021 Conditions 1087-1089 Millbury St. Lower Section To Millbury St.

Runoff = 3.00 cfs @ 12.10 hrs, Volume= 0.201 af, Depth> 5.42"
 Routed to Link MS : Design Point - Millbury Street

Tc (min)	Length (feet)	Slope (ft/ft)	Velocity (ft/sec)	Capacity (cfs)	Description
3.0	50	0.1000	0.28		Sheet Flow, Sheet Flow - Grass
					Grass: Short n= 0.150 P2= 3.13"
0.8	89	0.0700	1.85		Shallow Concentrated Flow, Shallow Concentrated
					Short Grass Pasture Kv= 7.0 fps
3.8	139	Total

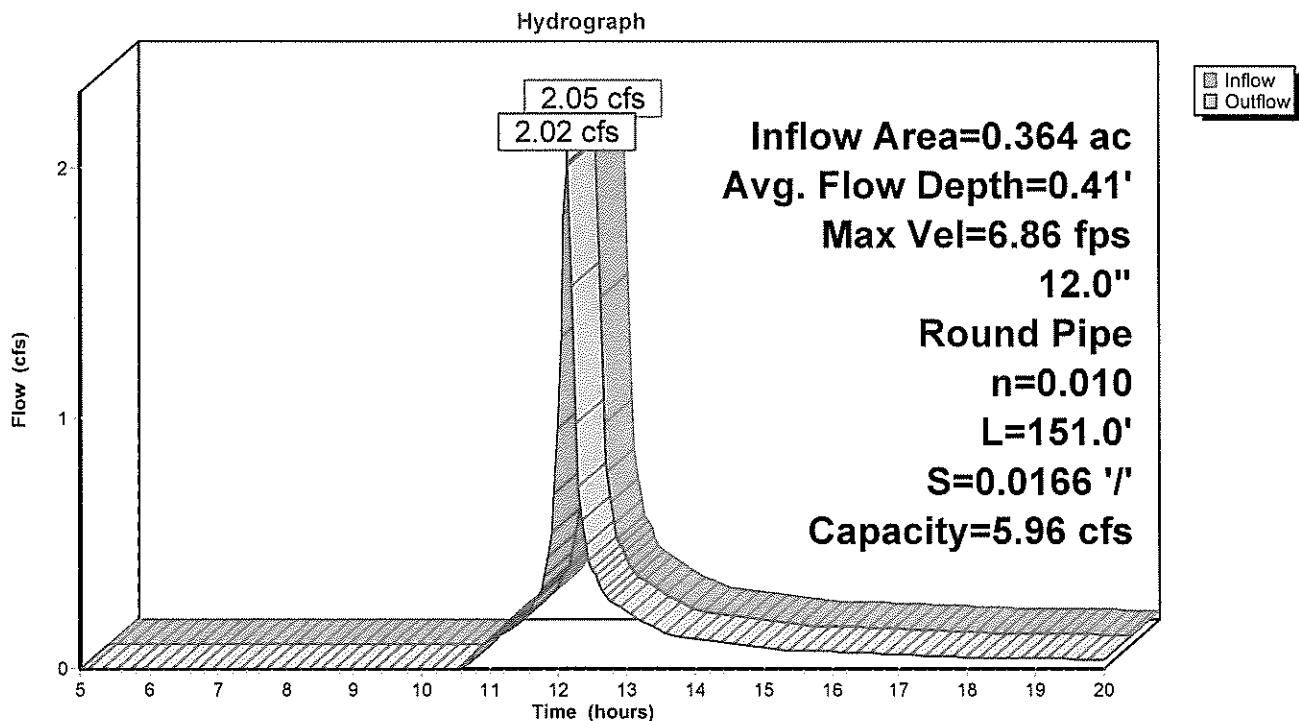
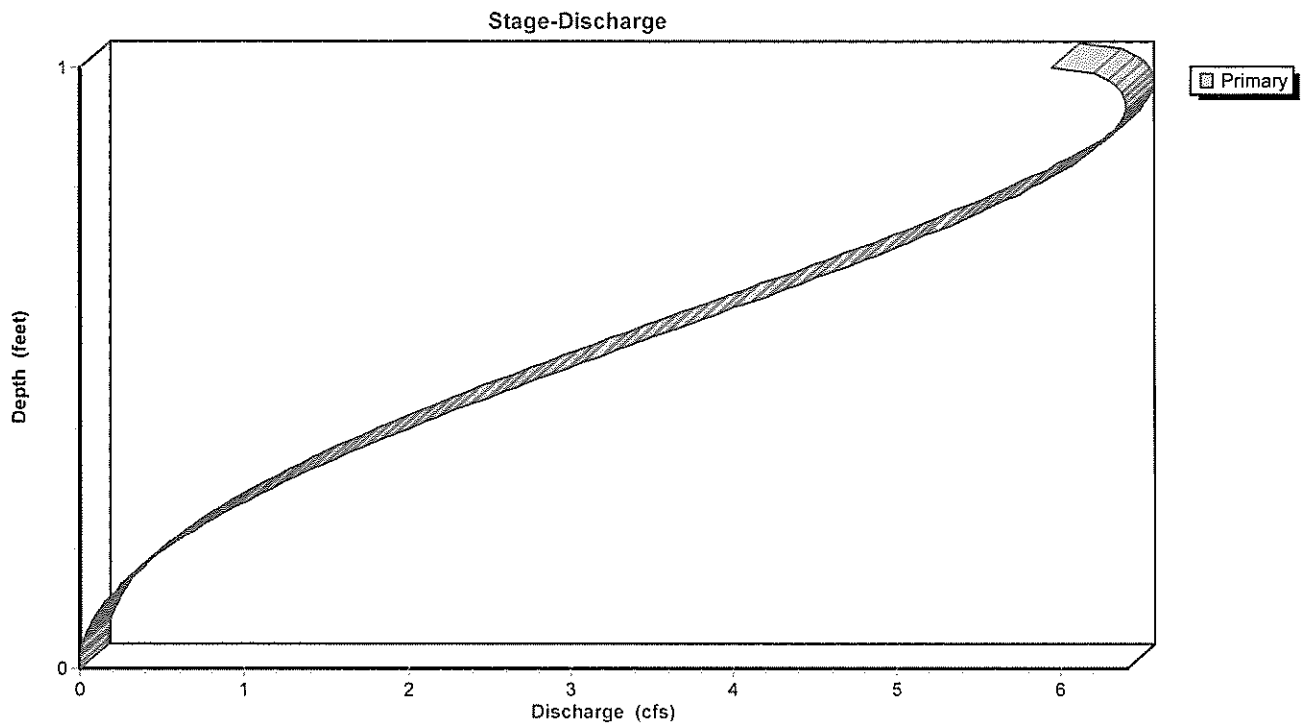
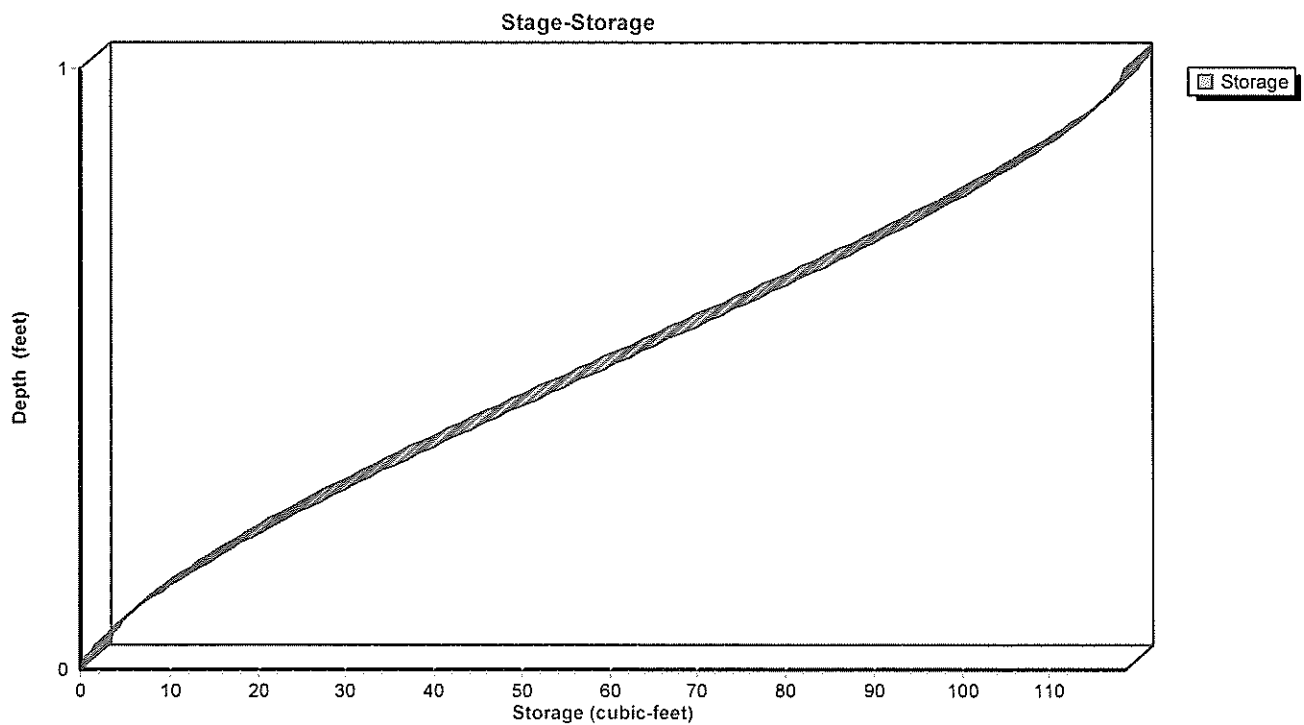
Summary for Reach DL: 12" D PVC Drail Line to CB2 in Millbury Street & Municipal Sewer

Inflow Area = 0.364 ac, 0.00% Impervious, Inflow Depth > 4.06" for 100-Year event
 Inflow = 2.05 cfs @ 12.13 hrs, Volume= 0.123 af
 Outflow = 2.02 cfs @ 12.14 hrs, Volume= 0.123 af, Atten= 2%, Lag= 0.6 min
 Routed to Link CB3 : Design Point - Municipal Catch Basin in Millbury Street

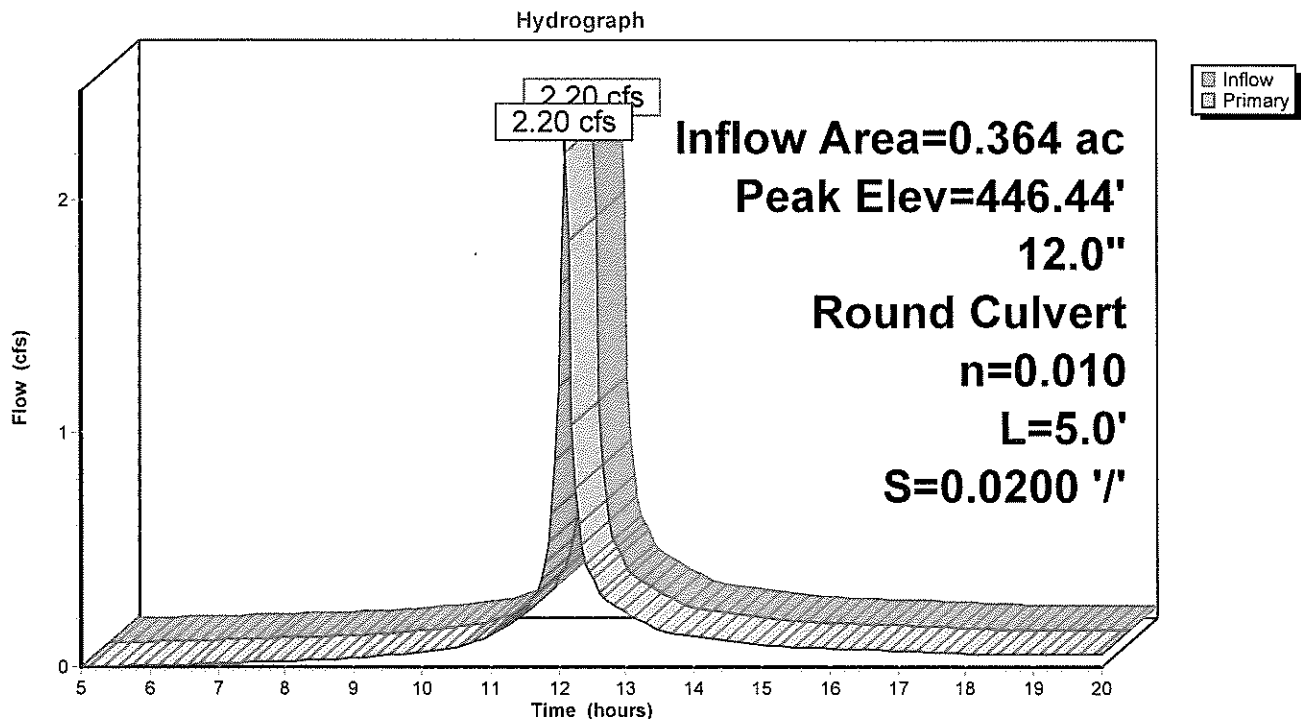
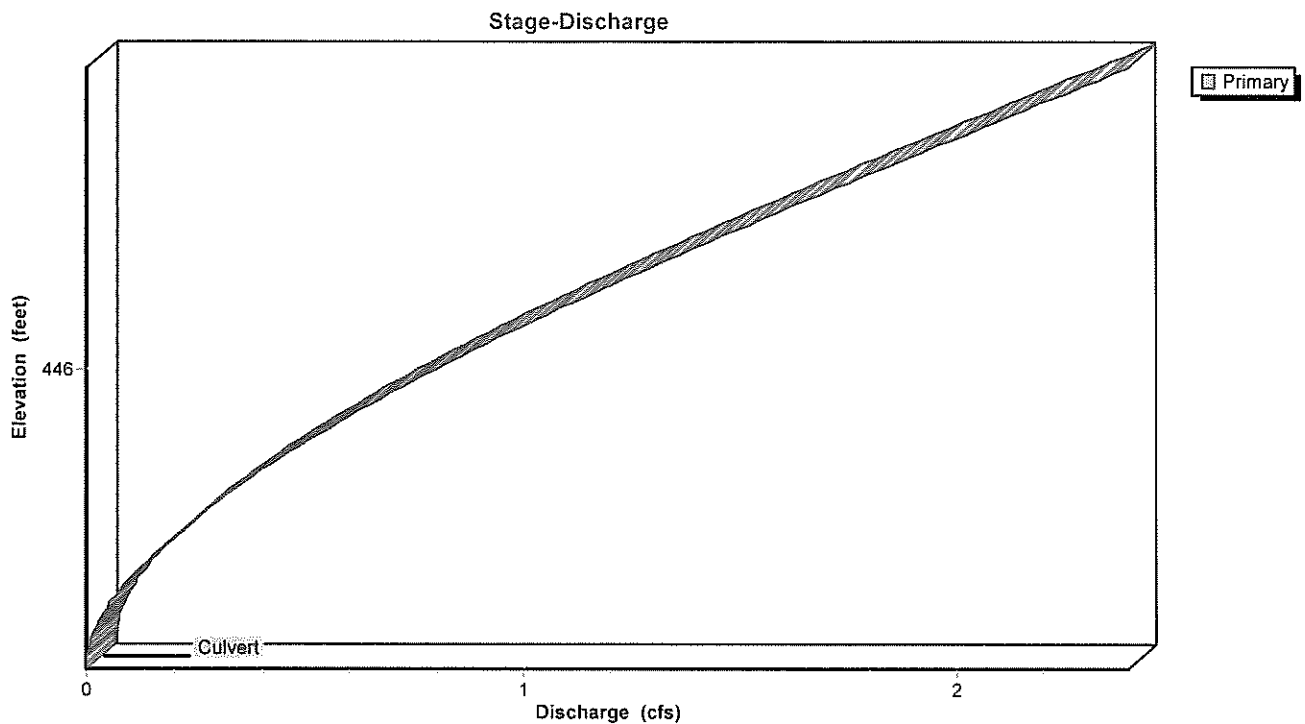
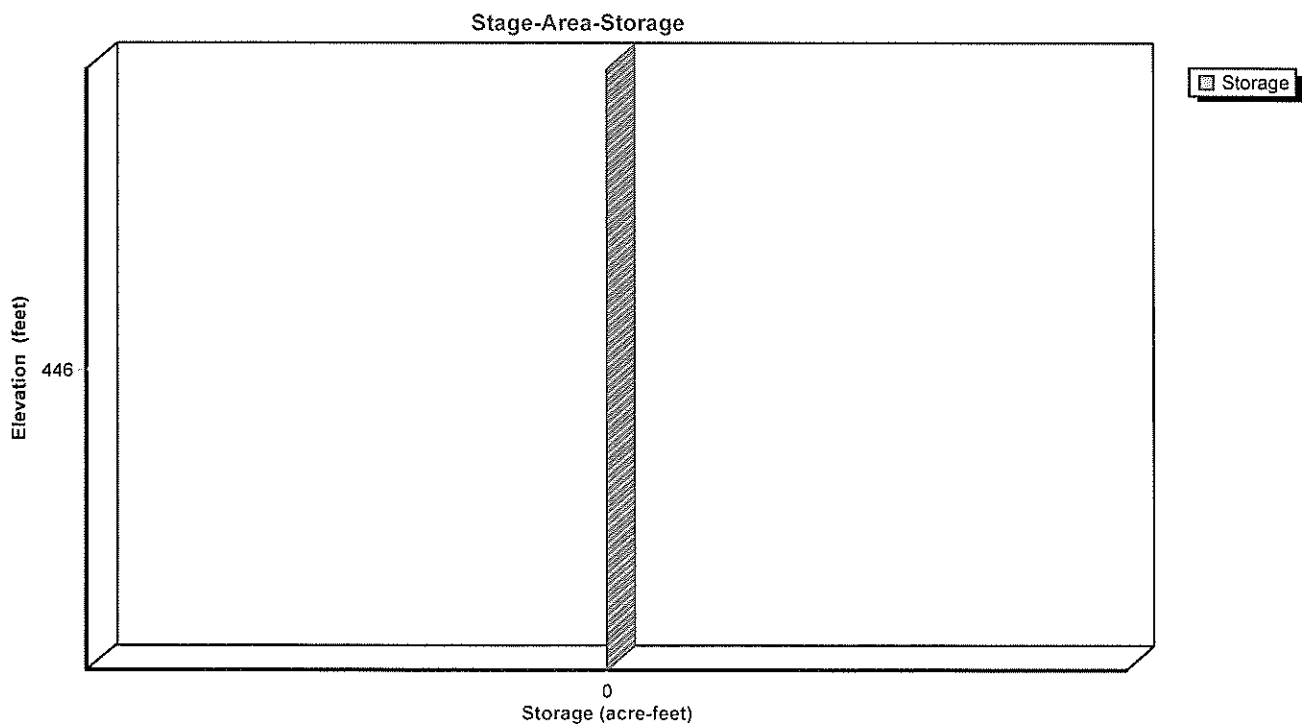
Summary for Pond CB1: Catch Basin 1

Inflow Area = 0.364 ac, 0.00% Impervious, Inflow Depth > 4.86" for 100-Year event
 Inflow = 2.20 cfs @ 12.10 hrs, Volume= 0.148 af
 Outflow = 2.20 cfs @ 12.10 hrs, Volume= 0.148 af, Atten= 0%, Lag= 0.0 min
 Primary = 2.20 cfs @ 12.10 hrs, Volume= 0.148 af
 Routed to Pond IT : Interceptor?Recharge Trench

Primary OutFlow Max=2.16 cfs @ 12.10 hrs HW=446.43' (Free Discharge)
 1=Culvert (Barrel Controls 2.16 cfs @ 3.69 fps)
